Navajo Abandoned Uranium Mine

Site Screen Report

Upper Red Wash AUM Site

March 2010

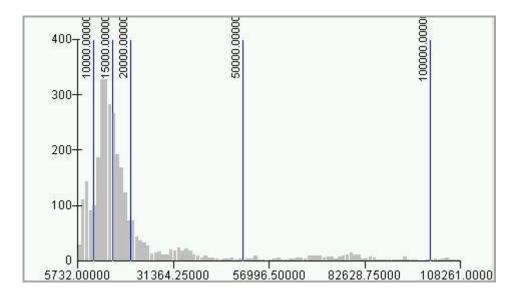
Mine ID # 31

108,261 counts per minute (cpm)

A total of 3,131 gamma radiation measurements were collected from the mine site, ranging from 5,732 cpm to 108,261 cpm. Measurements collected near the hogan southeast of the site were found at levels of approximately 100,000 cpm. The measurements are represented in Figures 1 and 2.

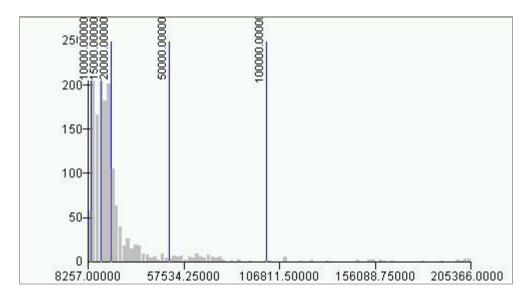
Mine ID # 32

205,366 counts per minute (cpm)

A total of 1,487 gamma radiation measurements were collected from the mine site, ranging from 8,257 cpm to 205,366 cpm. The measurements are represented in Figures 1 and 2.

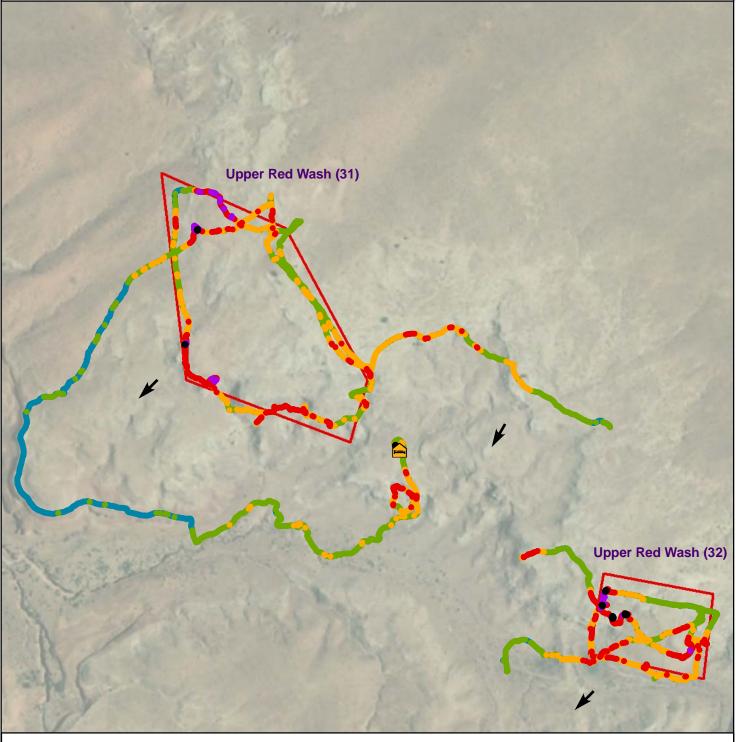
Figure 2 - Gamma Radiation Measurements Upper Red Wash (31, 32) Red Valley Chapter, Navajo Nation, Arizona

Gamma survey conducted 10/2009 Measured as counts per minute (cpm)

Average background 10,693 cpm
